To: Travis Underhill, PE – City of Franklin – City Engineer
Board of Works - City of Franklin

From: Andrew Cochran, PE – Whitaker Engineering, PC
Chris Breinling, PE – Whitaker Engineering, PC

RE: Youngs Creek Flood Investigation

Date: May 5, 2014

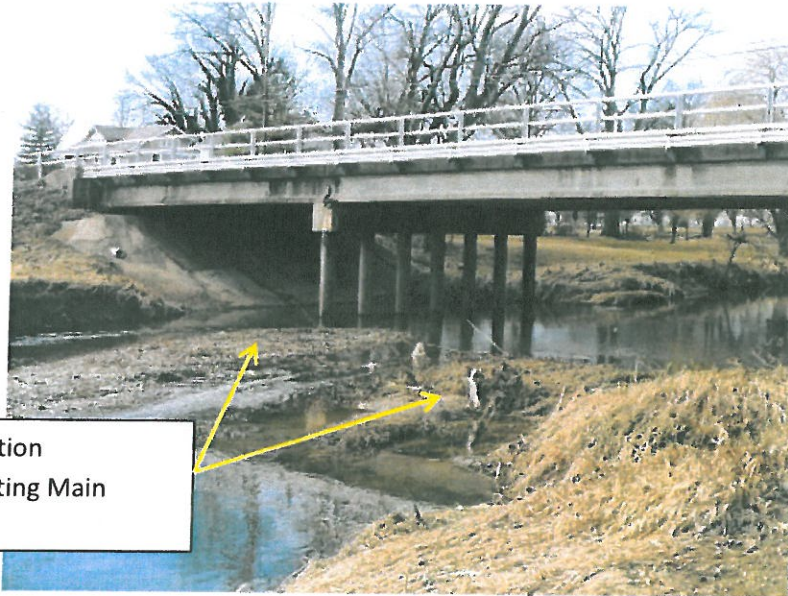
The existing streambanks of Youngs Creek have eroded slopes and moderate to severe undercutting has formed a soil overhang. The erosion is a potential threat to the existing pedestrian bridges, the trail, and access roads located along Youngs Creek within Province Park. The eroded sediment from the embankments builds up under the local bridge structures and elsewhere along the stream. In addition, sediment is transported from the upstream watershed during storm events and deposited in Province Park. Both factors contribute to the reduction in the flow capacity of the creek through Province Park. The contraction reaches of the Main Street and South Street bridges are unusually constricted. In addition, sand bars have been created in the expansion reach of the Main Street Bridge (see photo on following page) making Youngs Creek susceptible to collecting debris during flood events and reducing the flow capacity of the creek. Flooding in the park is expected to occur considering its location; however, there is a financial impact associated with each event.

Sediment accumulation
downstream of existing Main
Street Bridge

Whitaker Engineering recommends that the City of Franklin undertake a minimum of Alternative #2 to address the current adverse hydraulic conditions associated with sediment accumulation at the three existing roadway structures examined in this document. This alternative will allow for full use of the existing openings on each of the roadway structures, discourage future sediment buildup and allow for the greatest hydraulic capacity at each one of these bridges.
