To: Travis Underhill, PE – City of Franklin – City Engineer
Board of Works - City of Franklin

From: Andrew Cochran, PE – Whitaker Engineering, PC
Chris Breinling, PE – Whitaker Engineering, PC

RE: Youngs Creek Flood Investigation

Date: May 5, 2014

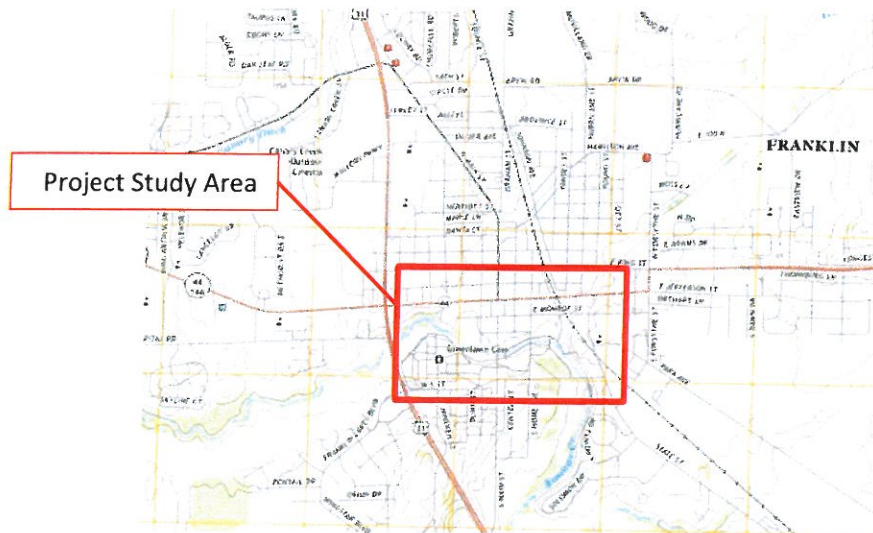
Figure 1: Youngs Creek Study Area

As part of the scope of work, costs were developed to normalize the creek cross-section, estimate dredged material, stabilize streambanks, and to propose alternatives to design and permit solutions. Numerous cross-sections were surveyed from South Street to Main Street to estimate the volume of material to be dredged and the cost associated with the dredging.
