Weatherization and Energy Efficiency

Repair and upgrade windows and doors

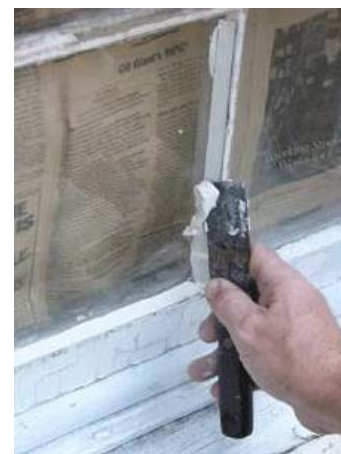
Some window repairs, such as reglazing, are relatively simple and perfect for do-it-yourself. More extensive repairs may require a professional.

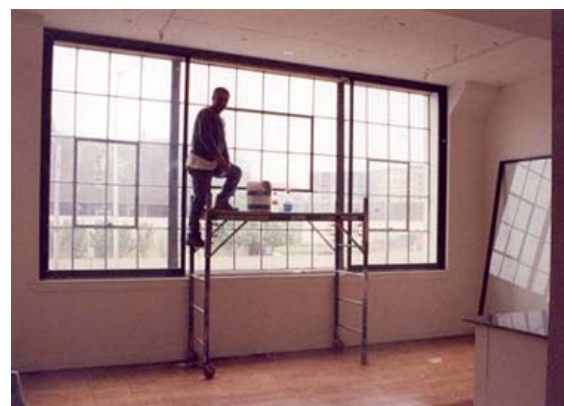
Storm windows can improve the efficiency of historic windows. These storm panels slide to allow the operation of the industrial windows.

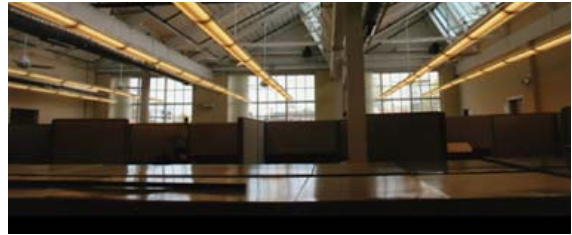
Historic buildings include many features, such as operating clerestory or cupola windows, designed to maximize ventilation and natural light.
